Marinetech Inc.
101 Rider Ave
Patchogue, NY 11772
www.marinetechology.info
email: info@marinetechology.info
(631) 704-4525

Pre-Purchase Marine Survey Report

Photo 1. Searay 320 Sundancer, year 2003 “XXXXXX”

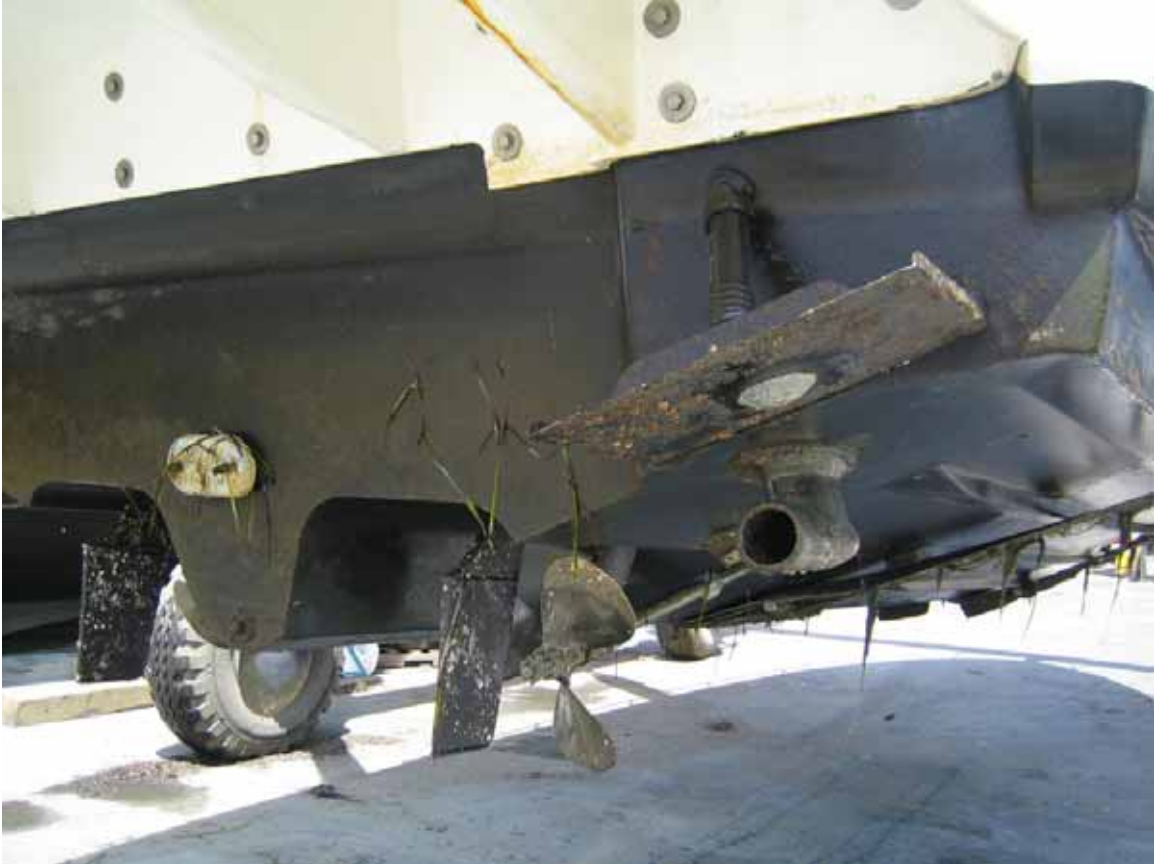
Photo 4. Close-up rudders, props, shafts, struts, trim tab, hull anode.

Anodes were noted in good condition and not due for replacement until next season.

FINDING	RECOMMENDATION
Excessive toe-in noted in rudders.	Adjust toe-in before next season launch.

DISCUSSION: Rudder parallel adjustment (toe-in) was measured as follows: distance between rudders in front of rudders = 37 inches. Distance between rear edges of rudders = 34 ¾ inches. Alignment should be between zero and ¼ inch difference front to back. Adjustment is made from inside transom by turning steel rod with locking nuts until correct spacing is achieved.

Excessive toe-in causes increased drag, slightly reducing fuel economy and lowers top end speed at wide open throttle.

FINDING	RECOMMENDATION
Moderate marine growth was observed on rudders and props.	Use special bottom paint, specifically designed for immersed metal next season before launch on submerged metal parts.

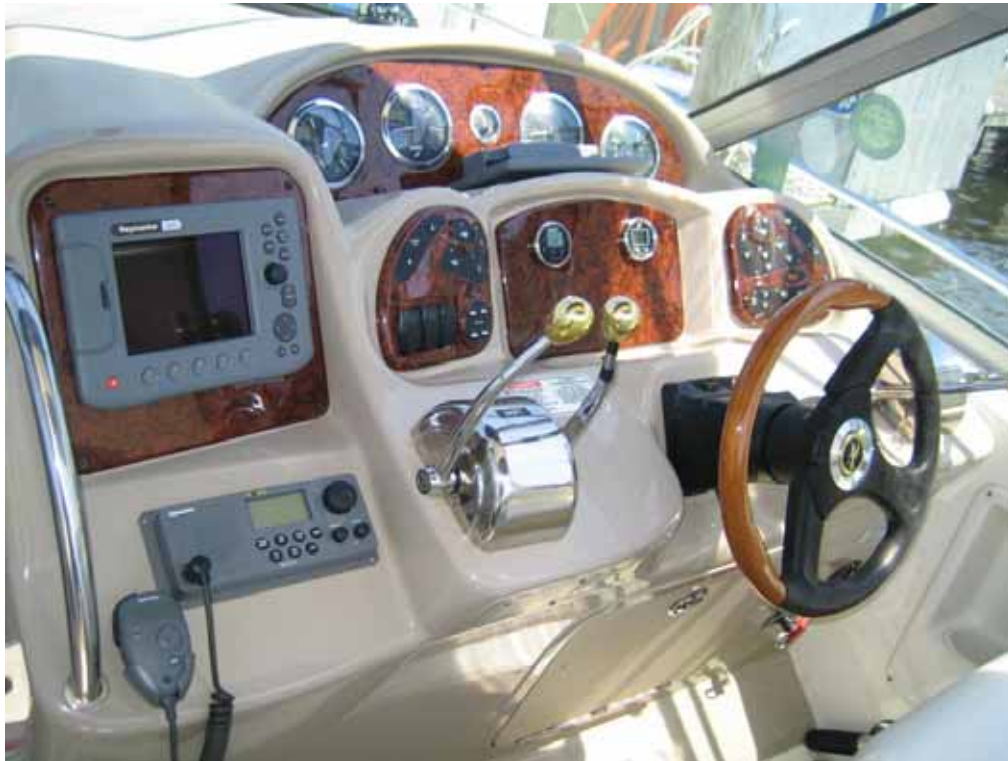
Photo 7. Helm.

Windshield-wipers were tested and operated mechanically but need new blades.

FINDING	RECOMMENDATION
Windshield wipers are damaged.	Replace.

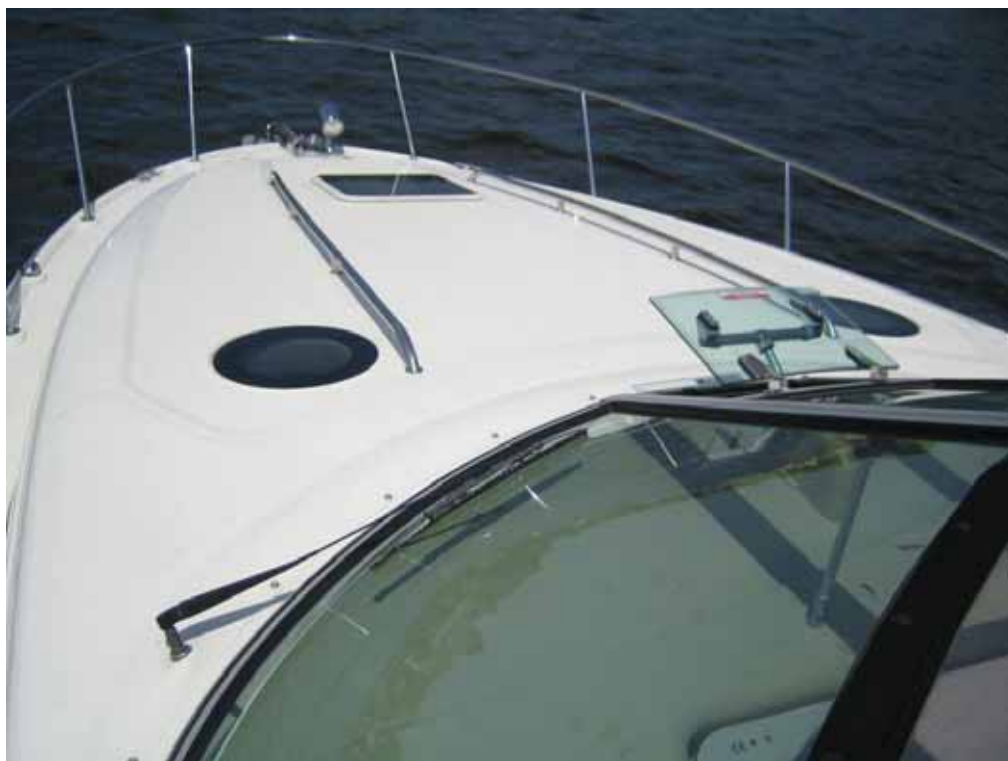
Photo 8. Foredeck.

Moisture measurements with Electro Physics GRP-33 moisture meter revealed no excessive moisture in randomly tested deck areas but tested slightly moist around windlass indicating that it should be removed and re-calked.

FINDING	RECOMMENDATION
Slight moisture detected on a 10” radius around windlass mostly to port.	Remove windlass, clean and re-caulk area.

DISCUSSION: The most effective way to permanently keep moisture from intruding core under windlass installation would be to drill over-sized holes on deck for bolts, epoxy-fill holes, and re-drill correct size holes through epoxy before caulking to positively seal core.

Approximate cost of restoring to original dry core condition is approximately \$5,000.

Percussion testing with a hammer revealed no de-lamination except for slight de-lamination by moist area to port of windlass.

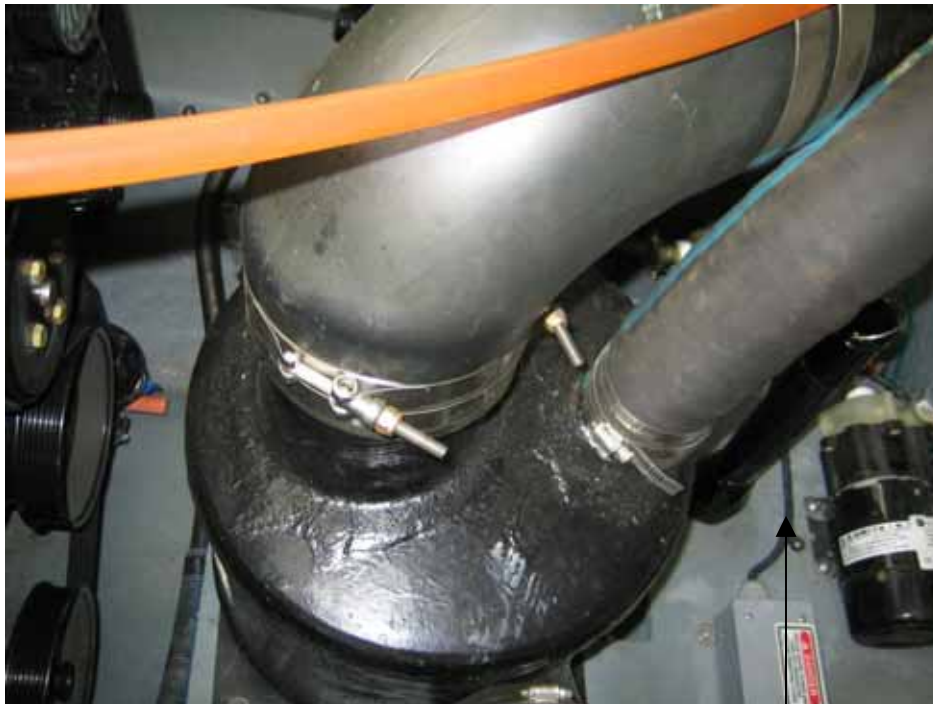
Photo 12. Aqua-lift fiberglass mufflers and hoses in good condition and double clamped.

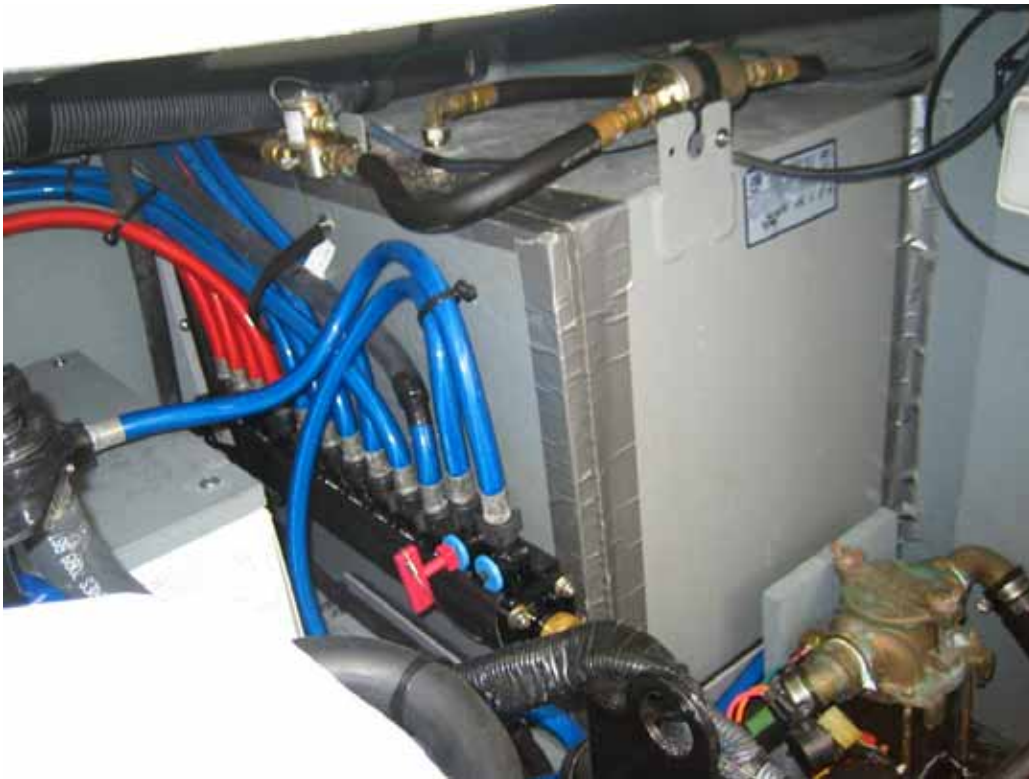
Photo 13. Port side 100 gallon fuel tank properly labeled and vented per ABYC Standards. Fuel hoses are Coast Guard approved and in good condition. Fresh water hot/cold manifold in foreground.

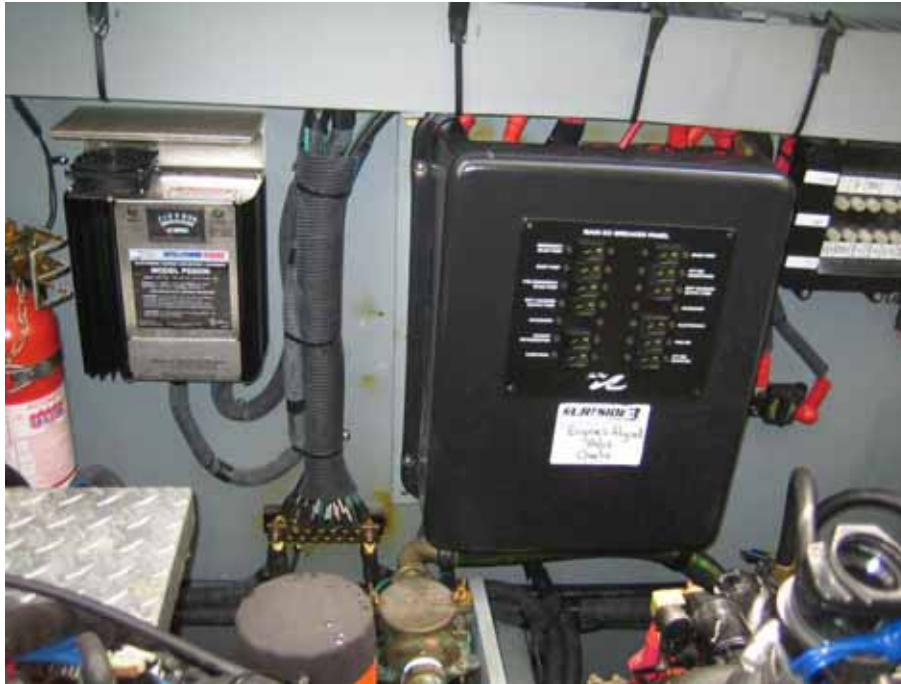
Photo 15. Intelli-power 30A battery charger to left, DC main panel to right.

FINDING	RECOMMENDATION
Battery charger does not power up.	Check fuses and wiring and replace charger if necessary

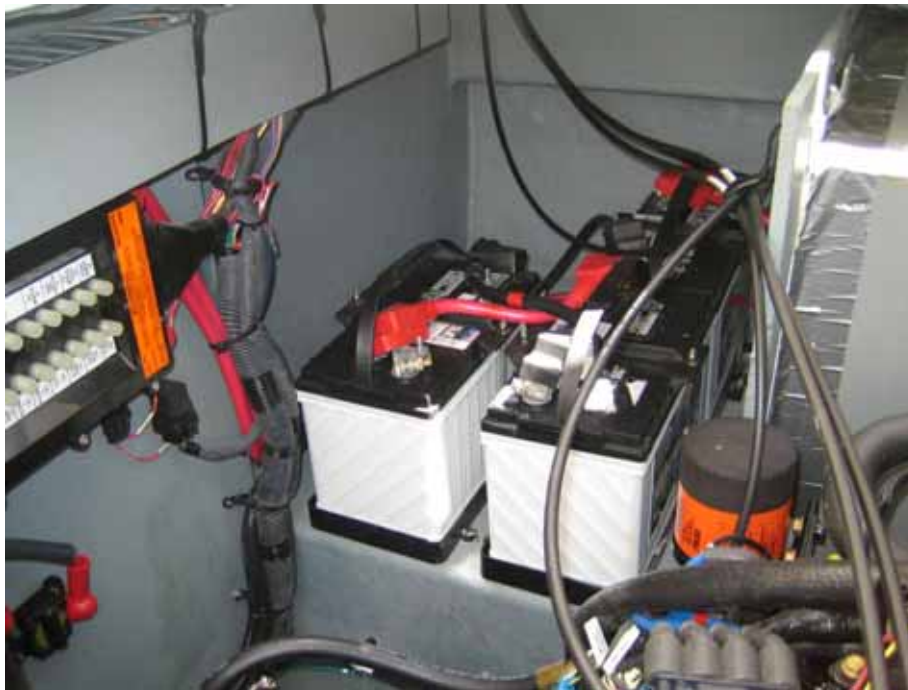
Photo 16. Three group 27 batteries were noted to starboard in engine room secured with positive terminal covered as per ABYC Standards. One is the house battery and the other two are port and starboard starting.

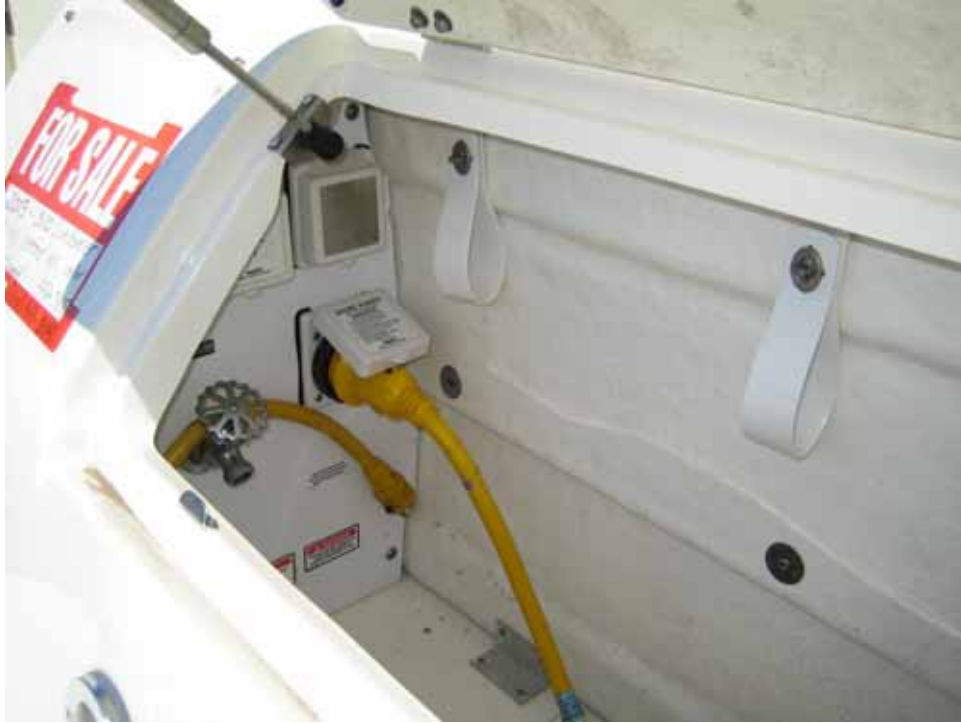
Photo 17. Inlet for 30A power installed to ABYC Standards and tested operational with multi-meter.

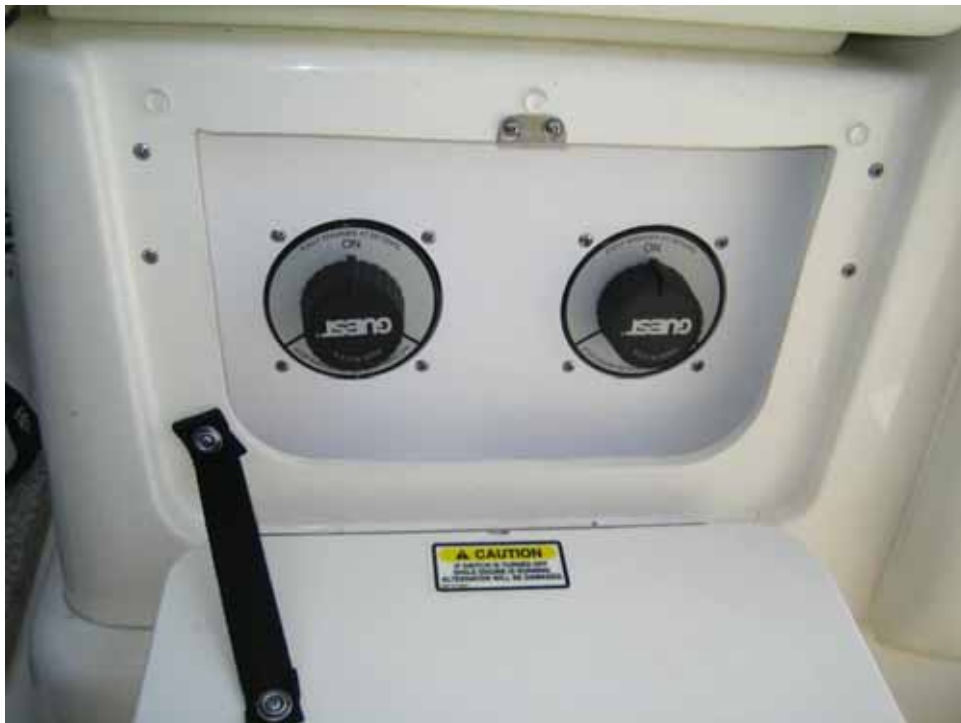
Photo 18. Battery switches under helm seat installed as per ABYC Standards.

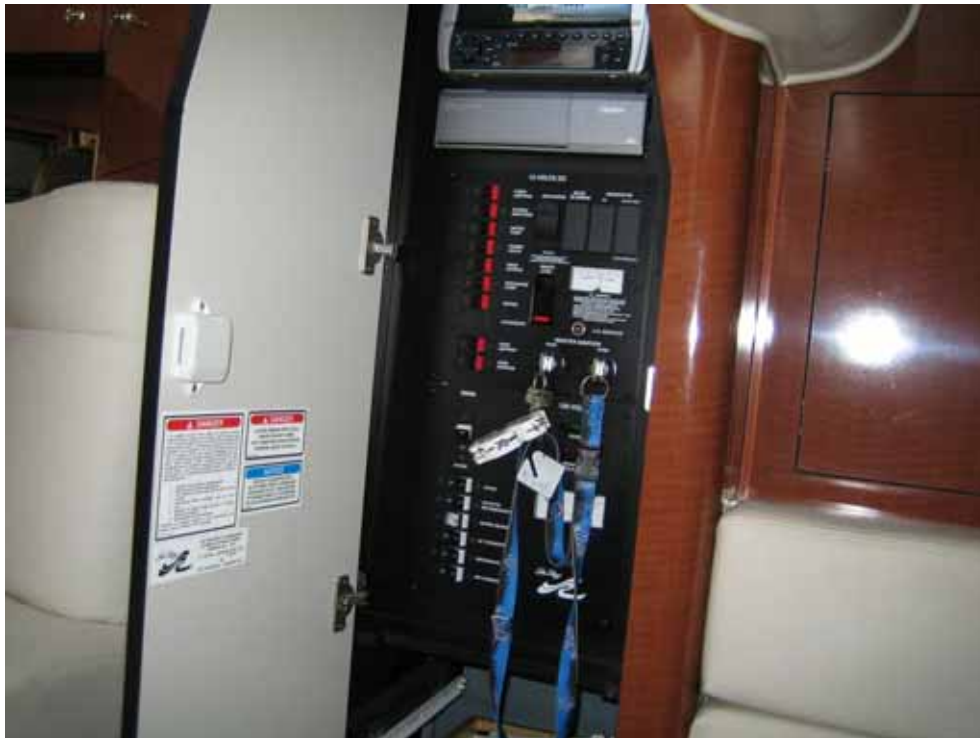
Photo 19. AC/DC breaker panel is installed in cabin as per ABYC Standards. Stereo visible above panel tested working.

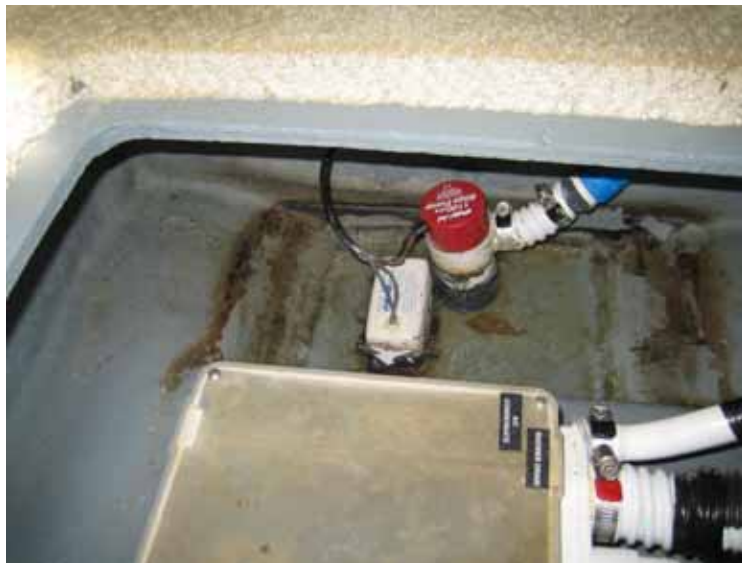
Photo 21. Bilge pump aft in engine room tested working.
