Marinetech Inc.
101 Rider Ave
Patchogue, NY 11772
www.marinetechology.info
email: info@marinetechology.info
(631) 704-4525

Pre-Purchase Marine Survey Report

Photo 1. Searay 320 Sundancer, year 2003 “XXXXXX”

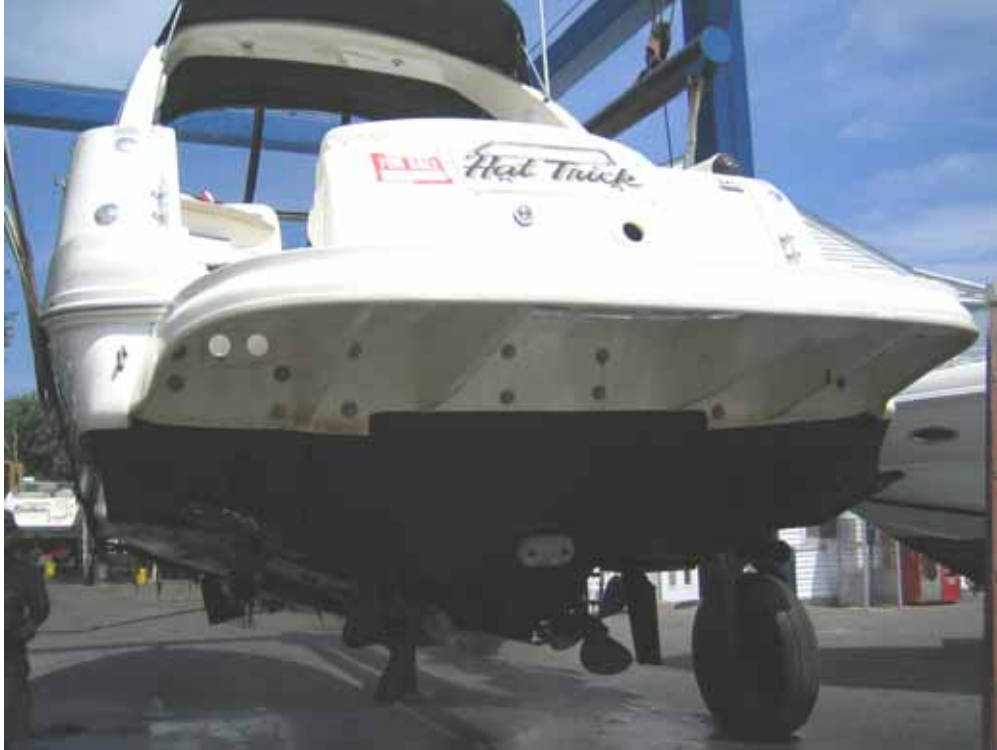
Photo 5. Stern view.

FINDING	RECOMMENDATION
Excessive toe-in noted in rudders.	Adjust toe-in before next season launch.

DISCUSSION: Rudder parallel adjustment (toe-in) was measured as follows: distance between rudders in front of rudders = 37 inches. Distance between rear edges of rudders = 34 ¾ inches. Alignment should be between zero and ¼ inch difference front to back. Adjustment is made from inside transom by turning steel rod with locking nuts until correct spacing is achieved.

Excessive toe-in causes increased drag, slightly reducing fuel economy and lowers top end speed at wide open throttle.

FINDING	RECOMMENDATION
Moderate marine growth was observed on rudders and props.	Use special bottom paint, specifically designed for immersed metal next season before launch on submerged metal parts.

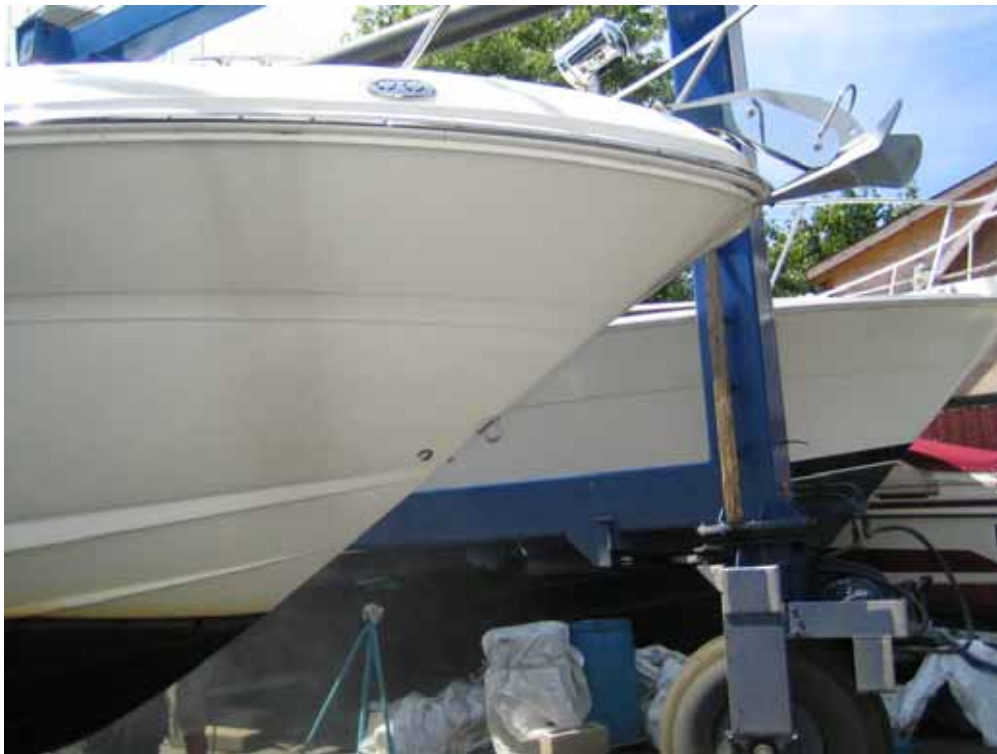
Photo 6. Close-up bow view and plow anchor on stainless roller.

FINDING	RECOMMENDATION
Slight moisture detected on a 10” radius around windlass mostly to port.	Remove windlass, clean and re-caulk area.

Percussion testing with a hammer revealed no de-lamination except for slight de-lamination by moist area to port of windlass.

DISCUSSION: The most effective way to permanently keep moisture from intruding core under windlass installation would be to drill over-sized holes on deck for bolts, epoxy-fill holes, and re-drill correct size holes through epoxy before caulking to positively seal core.

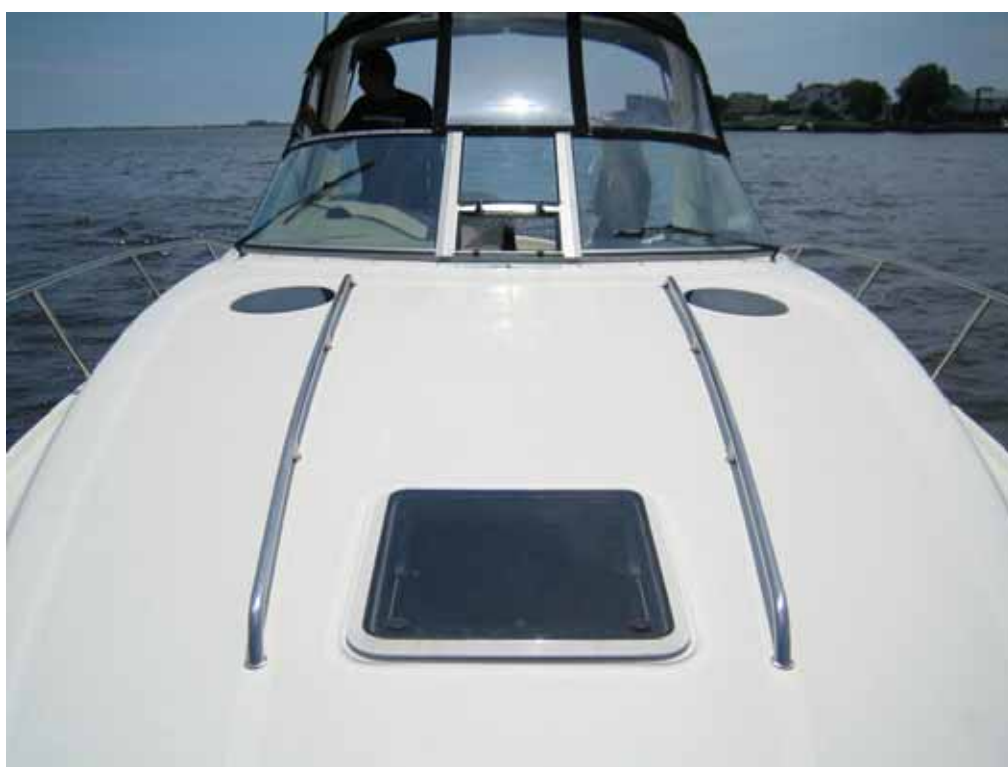
Moisture measurements with Electro Physics GRP-33 moisture meter revealed no excessive moisture in randomly tested deck areas but tested slightly moist around windlass indicating that it should be removed and re-calked.

Photo 9. Foredeck looking aft.

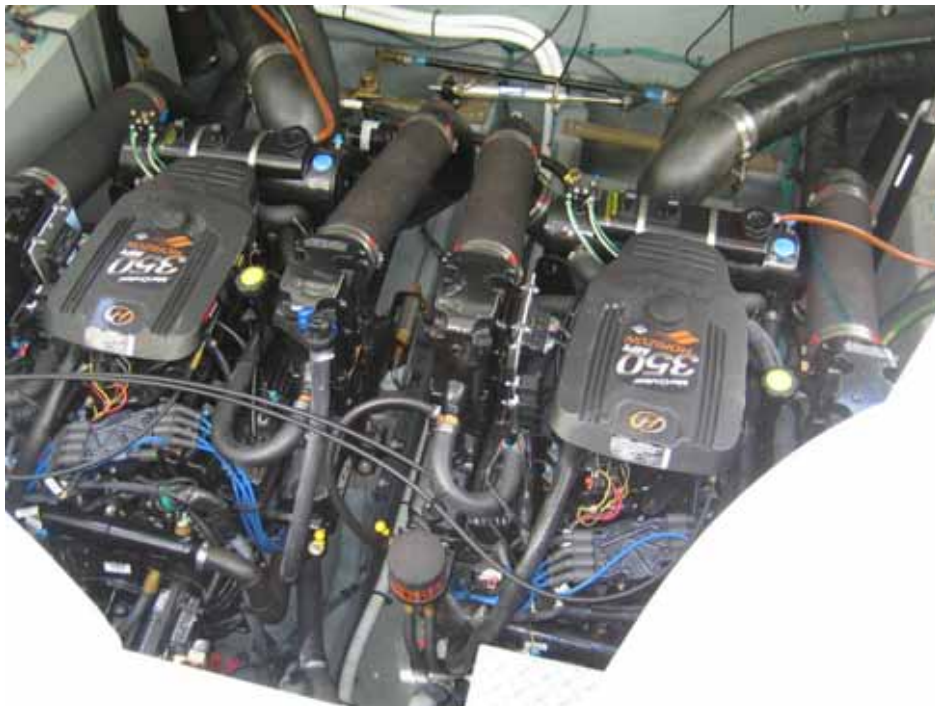
Photo 11. Engine room.

FINDING	RECOMMENDATION
Portside engine cooling water intake seacock frozen in open position.	Free and lubricate.
